No. : SHMR090401161 Date : Apr.14,2009 Page: 1 of 7

Sample Name	:	FORMEX GK-17 BK
Sample No.	:	SHMR090401161
Product specification	:	FORMEX GK-17 BK
Date of Receipt	:	Apr.02,2009
Test Period	:	Apr.02,2009 to Apr.13,2009
Test result(s)	:	For further details, please refer to the following page(s)

### 1. Temperature rapid change test #1 (refer to IEC 60068-2-14 Nb: 1986 & as per client's requirement)

### 3. High potential test (Refer to IPC-TM-650 2.5.6.1 & per client's requirement)

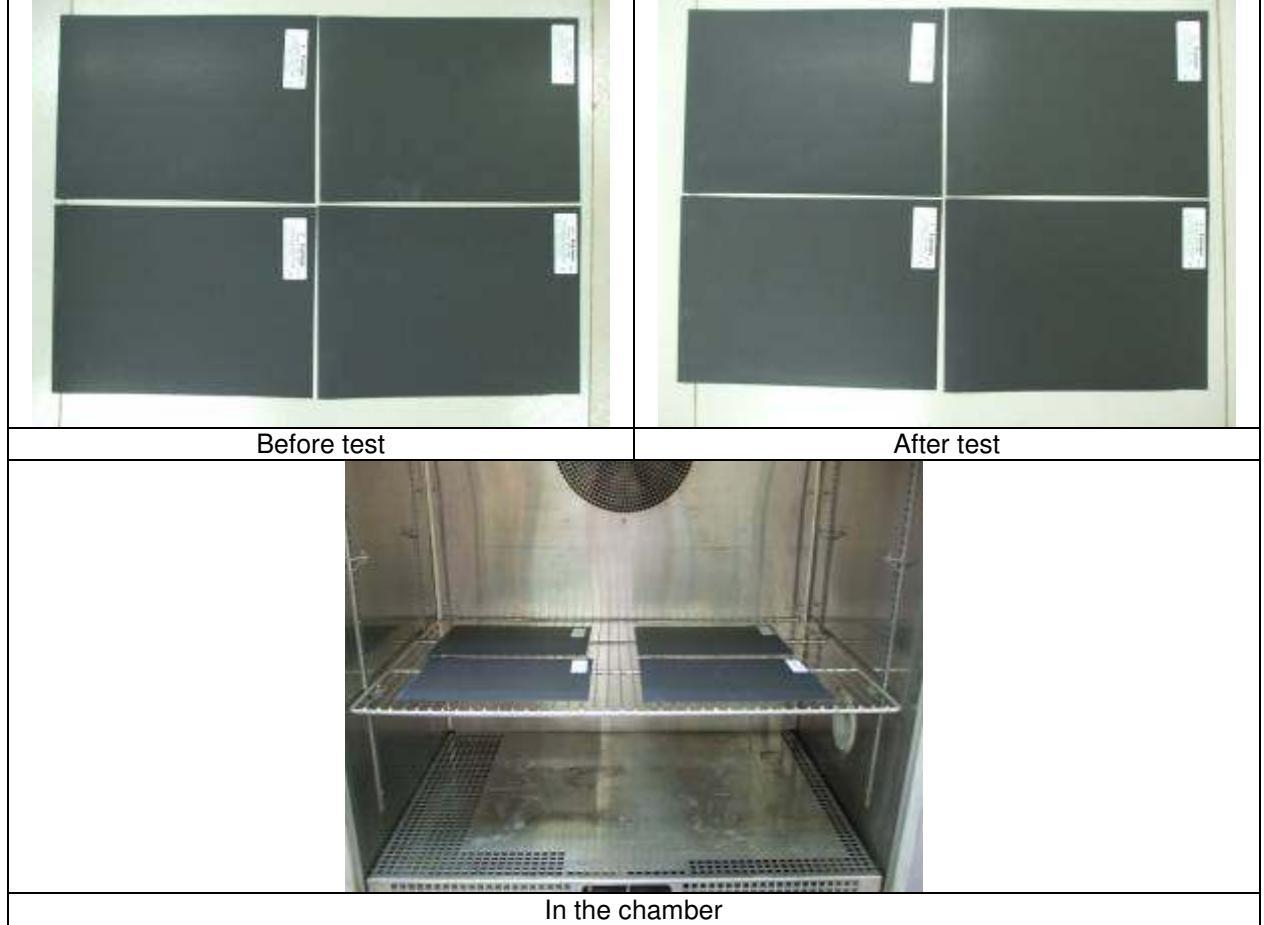
### 1.5 Test photos:

- Step 1: Expose sample to room temperature (23 °C/ 50%RH) for 1 hour.
- Step 2: Change time: 1 hour. ( $23^{\circ}C \rightarrow -55^{\circ}C$ )
- Step 3: Expose sample to cold temperature  $(-55^{\circ}C)$  for 24 hours.
- Step 4: Change time: 1 hour. (-55°C→23°C)
- Step 5: Expose sample to room temperature (23  $^\circ\!C/$  50%RH) for 24 hours.

In the chamber

Sample No.	Visual check after test
#1 $\sim$ #4 (Group one)	No signs of cracking, discoloration or bubbling after test.

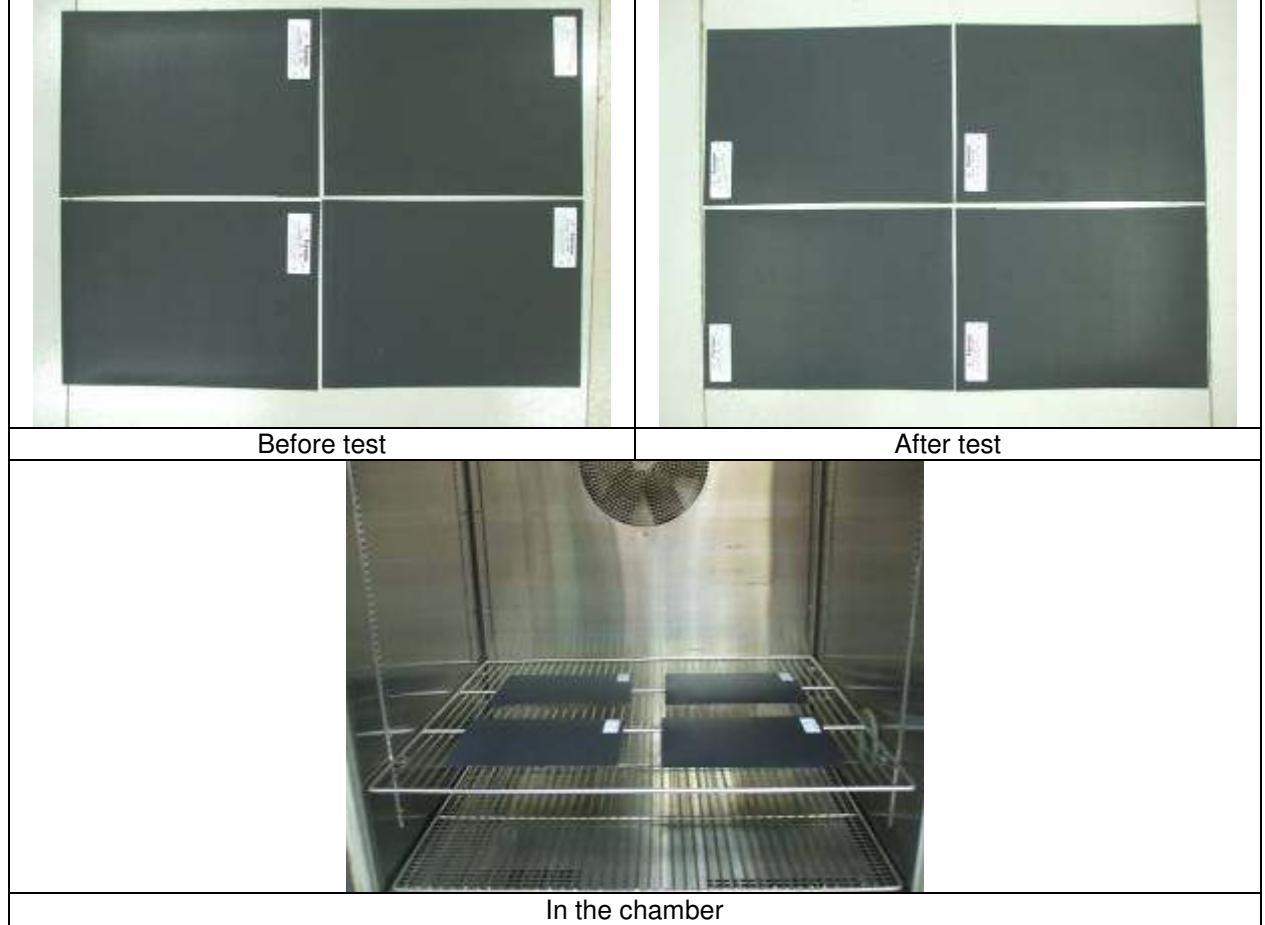
#### 2.5 Test photos:

- Step 1: Expose sample to room temperature (23 °C/ 50%RH) for 1 hour.
- Step 2: Change time: 1 hour. ( $23^{\circ}C \rightarrow -55^{\circ}C$ )
- Step 3: Expose sample to cold temperature  $(-55^{\circ}C)$  for 48 hours.
- Step 4: Change time: 1 hour. (-55°C→23°C)
- Step 5: Expose sample to room temperature (23  $^\circ\!C/$  50%RH) for 48 hours.

In the chamber

Sample No.	Visual check after test
#1 $\sim$ #4 (Group two)	No signs of cracking, discoloration or bubbling after test.

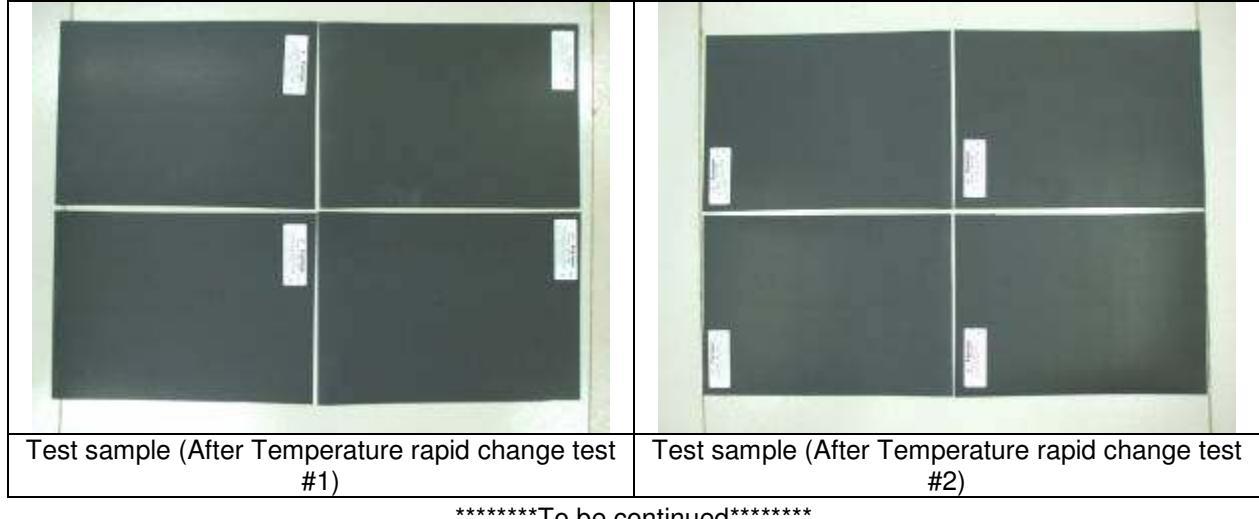
### 3.3 Test photo:

High potential test (3000VAC/1minute)					
San	nple No.	#1	#2	#3	#4
	Temperature rapid change test #1	Pass	Pass	Pass	Pass
Test result	Temperature rapid change test #2	Pass	Pass	Pass	Pass

Note: 1.Pass = No signs of breakdown, flashover or leakage.
